THE CHERLOC PROJECT: AN EXPERIMENTAL CASE STUDY OF MARINE STRUCTURES COMBINING ENGINEERING AND BIODIVERSITY

O Paireau, E Cunge, C Giraudel, Dominique Mouazé, Aurore Raoux, et al.. THE CHERLOC PROJECT: AN EXPERIMENTAL CASE STUDY OF MARINE STRUCTURES COMBINING ENGINEERING AND BIODIVERSITY. ICE Coasts, Marine Structures and Breakwaters, Apr 2023, London, United Kingdom. hal-04251312

O. Paireau¹, E. Cunge¹, C. Giraudel¹, D. Mouaze², A. Raoux², M. Charbonnelle², R. Van Paemelen², A. Gutierrez¹, M. Baumbach¹, JC Dauvin², P. Claquin², M. Deloor², JP Pezy²

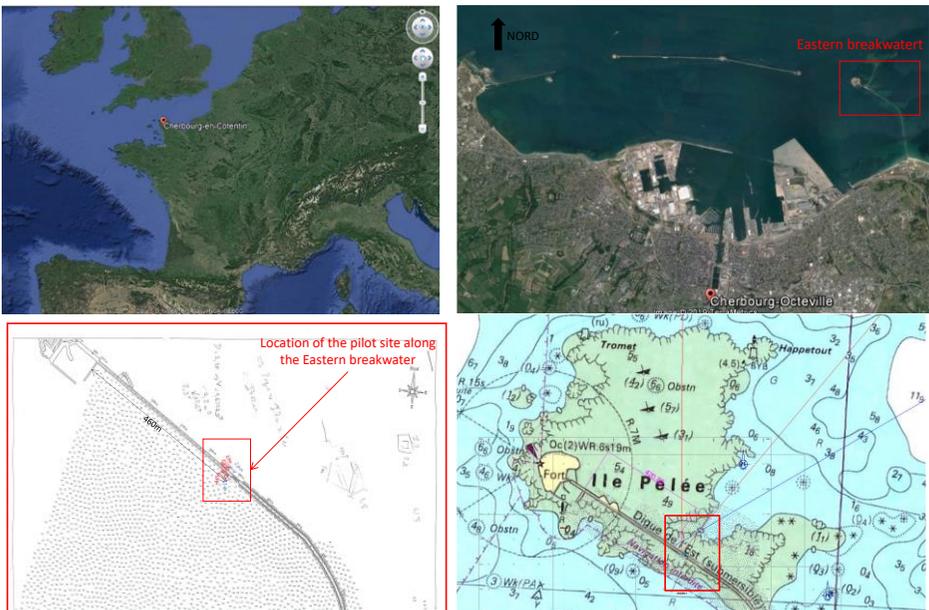
Figure 1 Location of the Cherbourg pilot site (France) and its exposure to wave actions. Source: *Google Earth, Nautical chart (SHOM)*.

The Cherbourg harbour is surrounded by three external breakwaters, i.e., the Querqueville breakwater to the west, the offshore breakwater and the eastern breakwater (Figure 1). The Cherbourg pilot site is exposed to two main directional wave sectors (Figure 2):

The bathymetry around the pilot section of the eastern breakwater is uneven, shallower to the west than to the east. The breakwater is in fact surrounded by a relatively high tidal reef, which is completely exposed at low spring tides (see bathymetry on Figure 1 and Figure 2). This shallowness has some effects on the wave propagation and refraction towards the structure, making the incident waves almost perpendicular to the breakwater when coming from the west.

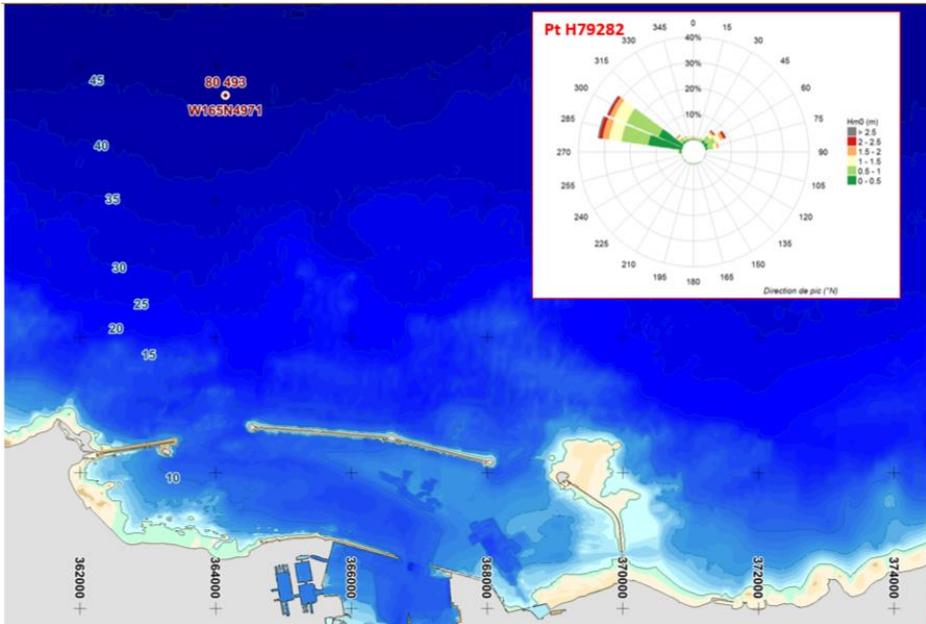
Figure 2 Local bathymetry at the pilot site and offshore main directional wave sectors (inserted detail)

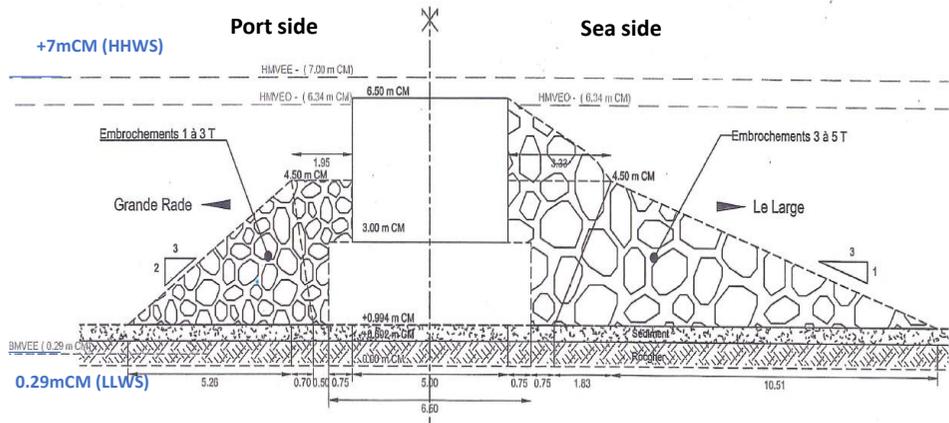
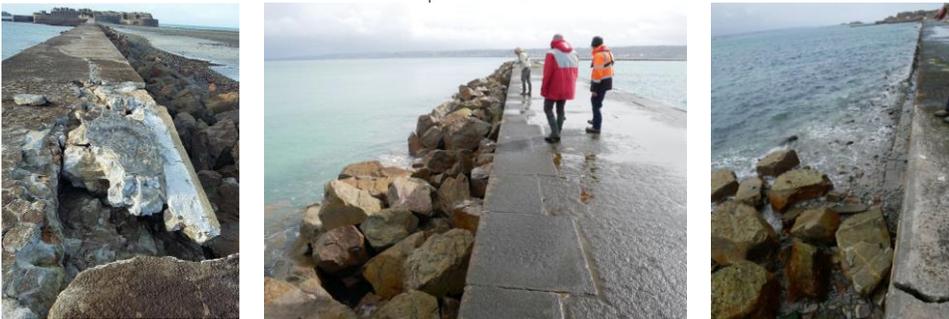
Figure 3 Cross-section of the original, now defunct, mixed breakwater (top) and the damage observed during the baseline survey in 2020 (bottom)

appropriate; but knowledge of it is essential for effective maintenance and rehabilitation in line with the original harbour appearance. Figure 3 shows the cross-section of the original Eastern breakwater consisted. However, this profile of the structure is now theoretical as nowadays the breakwater no longer corresponds to this configuration.

The Eastern breakwater was damaged on several occasions and the most recurrent problem is missing rocks, observed especially on the seaward side, where the rock slope protection has been either partially eroded or completely removed. It is not uncommon to see large rocks (3-5t) that have been extracted and transported far away from the armour layer.

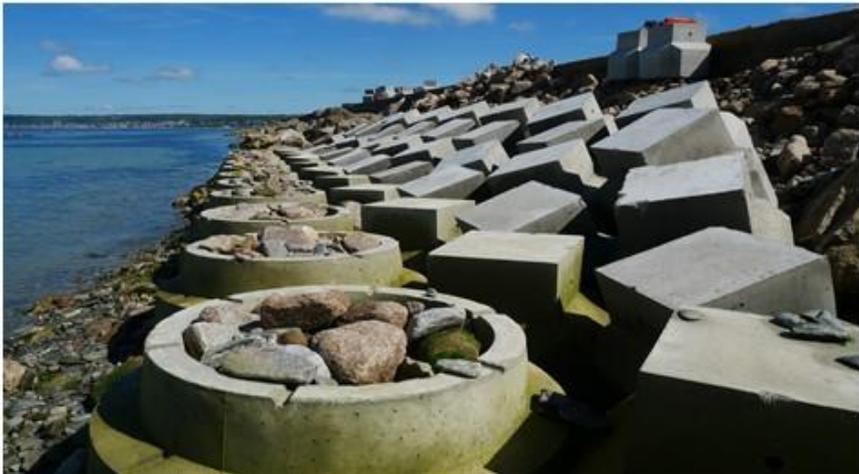
Figure 4 - ACCROBERM™ II toe blocks filled with rocks (at the bottom of the repair solution) interlocked with Double-Cube blocks placed on the slope

This later toe armour block is designed for coastal structures and breakwaters, and to replace “classic” toe rock and limit direct and indirect environmental impacts, especially with a reduced seabed footprint and an enhanced cavity. This hole-shaped block is cylindrical with a low centre of gravity and an annular shape designed to be filled with rocks. The stability of the ACCROBERM™ II toe block is ensured by the rock filling which can use different rock categories arranged in accordance with the specific site in order to create a heterogeneous environment and attract larvae, both juveniles and adults, creating a new artificial ecosystem or recreating the pre-existing ecosystem.

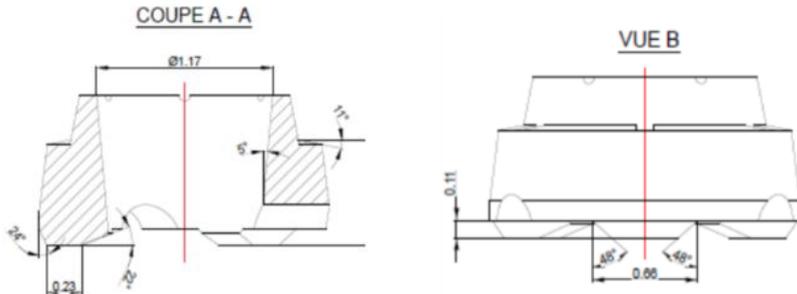
Figure 5: Details of the new ACCROBERM™ II toe block

The aim of this new ACCROBERM™ II block is to provide two functionalities, i.e., both a toe block and a support for biodiversity by providing new habitats including micro-habitats.

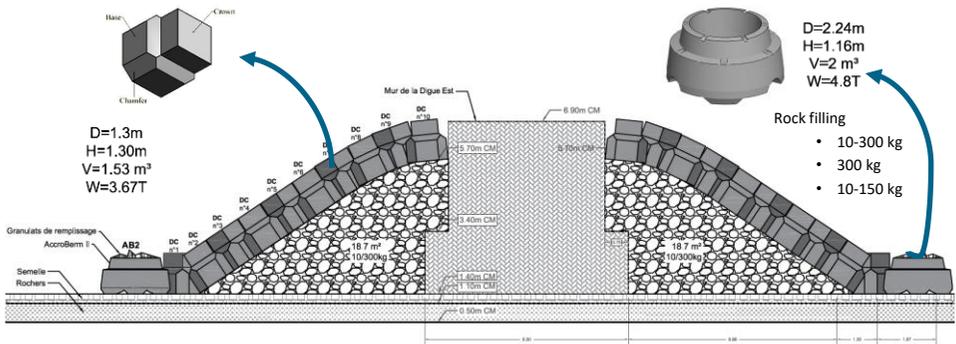
Figure 6 Cross-section of the repair solution

Prior to the in-situ experiments in Cherbourg, the repair solution had already been developed (Figure 6).

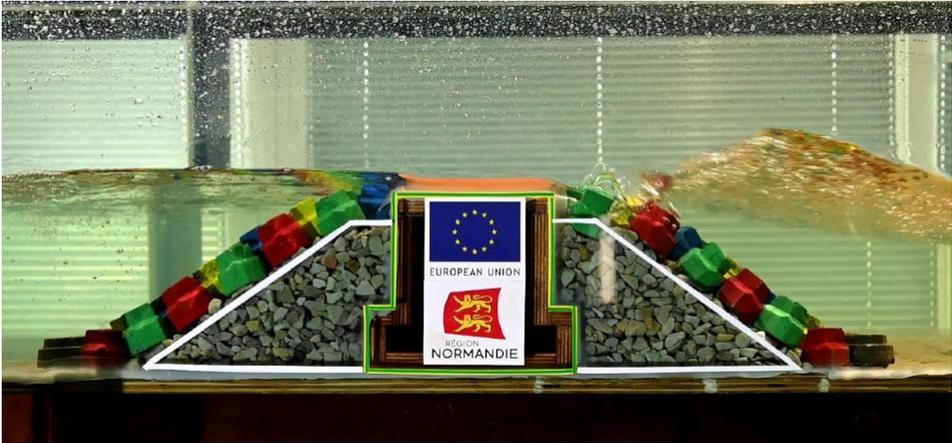
Figure 7 2D tests for Cherbourg pilot site (ESITC wave flume)

- Design/sizing of both new blocks for their integration into the existing damaged structure, especially the ACCROBERM II™ toe armour blocks,
- Sizing of rockfill specifications in collaboration with the ecologists and in accordance with the environmental conditions; placement of ACCROBERM™ II blocks is envisaged by testing three categories of ballast rocks: 10-150kg, 10-300kg and 300kg. This flexibility in filling should allow for changes in gaps/cavity and thus adapt to the local ecological environment,
- Verification of the hydraulic stability of the ACCROBERM II™ blocks in a wave flume (2D physical model) under storm conditions and with different design sea levels (see Figure 7),

- The physical modelling conducted in the ESITC wave flume verified the stability of the blocks. The 2D tests were carried out for different block arrangement configurations and extreme wave conditions of up to 100-y waves with a high water level (Figure 7),
- These series of 2D tests confirming the sizing of the blocks allowed block fabrication at the prototype scale to begin.

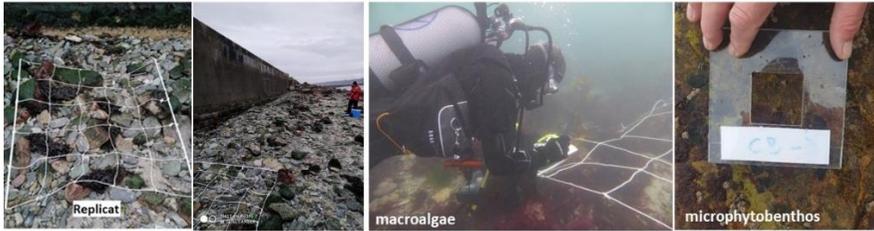
Figure 8 Algal ecological survey for Cherbourg pilot site (BOREA – University Caen Normandy investigations).

This survey was performed during four sampling campaigns conducted on the hard substratum of the half-tide zone (Figure 8 and Figure 10). The samples collected were sorted and analysed. The objective is to perform a comparative study of the biodiversity found on marine structures protected by existing rock materials and on the planned new concrete armour blocks, using ecosystem approaches for macroflora, macrofauna and microalgal biofilm. In addition, every quarter a monitoring of the artificial blocks was made at each site and thus during one year.

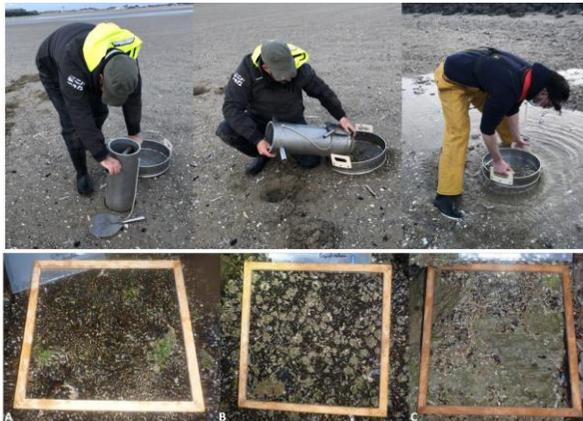
Figure 9 Faunal ecological survey for both sites (M2C – University of Caen) for soft-bottom substratum (above) and hard-bottom substratum (below).

Figure 12 shows the change in time of the wildlife diversity (fauna taxonomic richness) from four sampling campaigns, two before the rehabilitation works with concrete armour blocks and two after. This wildlife diversity parameter is measured in a 0.1 m² framework (Figure 9) during one year and four months on different stations along the breakwater. A difference in taxonomic richness is observed for different stations and sampling periods. Samplings on the breakwater (both internal and external sites) showed the smallest variation in richness. The greatest taxonomic richness was observed in the lower half-tide artificial block on both harbour side and the seaward side.

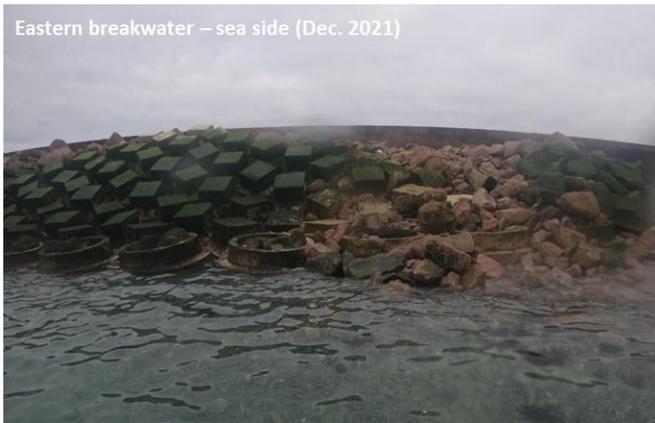
Figure 10 Cherbourg Experiment in December 2021 after the aforementioned storm events which appear to have a 5-10-year return period

In December 2021, during the first year of survey, the Cherbourg pilot site was subjected to a series of relatively severe storm events. These storms (i.e., ARWEN on 27th November 2021 and BARRA on 6th to 8th December 2021) caused some damage to the rubble mound rock armour (existing structure) while the repaired part with concrete armour blocks remained stable (see Figure 10). For this study, and in order to assess the in-situ stability, we performed storm reconstruction for the whole of 2021 using the existing SWAN wave

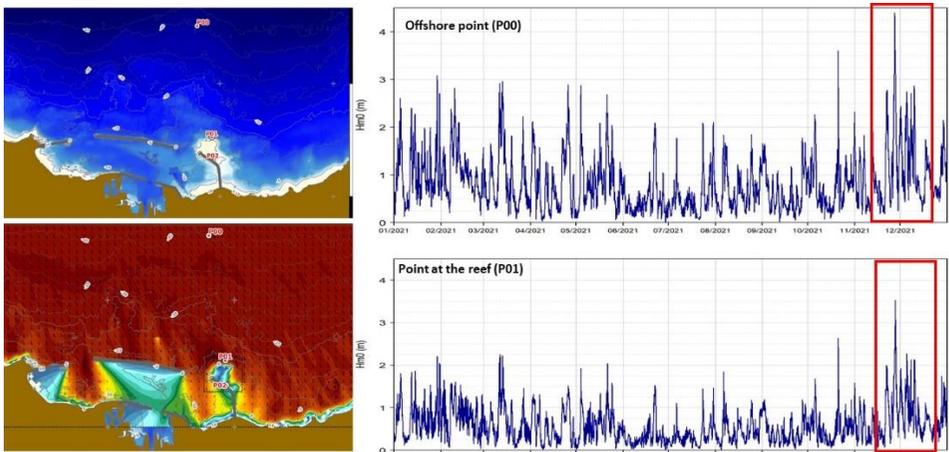
Figure 11 December 2021 Reconstruction of storm events based on the existing wave model made for the Cherbourg project

- Following this reconstruction (see Figure 11), the storm events that occurred in December 2021 are characterised as follows:
- the extreme value of the time-series at the offshore point (P00) corresponds to about $H_{m0}=4.5\text{m}$,
- the extreme value of the time-series at the nearshore point (P01) corresponds to about $H_{m0}=3.5\text{m}$,

These values match with the storm event of 27th November 2021 and if we consider the values at the offshore point which was not affected by the water levels, the return period of this storm might be considered as around 5 years. Further investigations, considering more accurately the water levels on the reef, are ongoing in order to estimate the characteristics of the waves (especially Return Period) at the toe of the eastern breakwater.

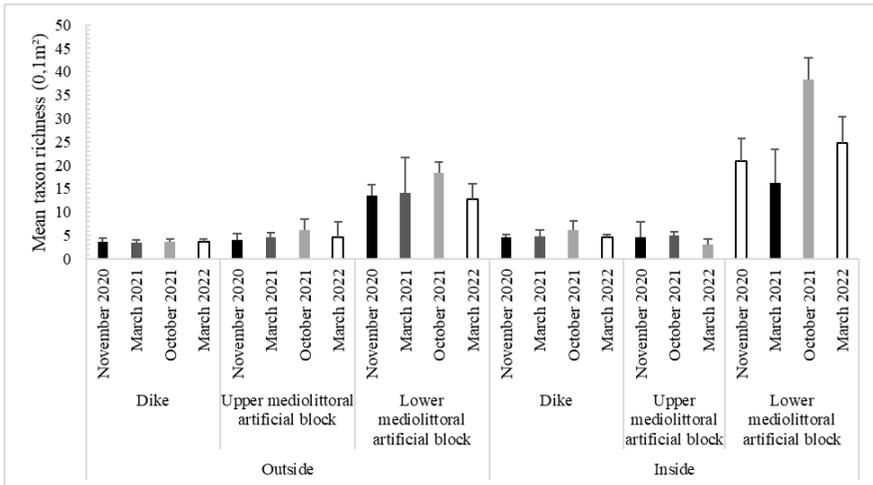
Figure 12 Mean faunal taxonomic richness measured during 1 year and 4 months

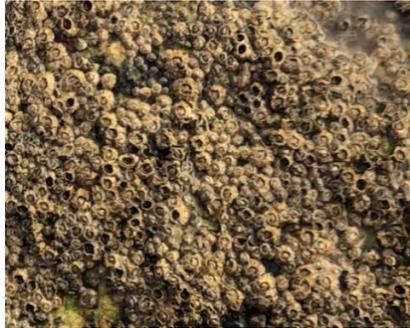
Figure 13: Barnacle crustaceans *Semibalanus balanoides* observed on site.

There is a dominance of the barnacle crustaceans *Semibalanus balanoides*, which represent 80% of the individuals sampled on all stations (Figure 13). This animal species is a fast growing pioneer species that provide a spatial heterogeneity on the support they colonise. This spatial heterogeneity provide support for epibiotic organisms. Although the diversity index is low, the ecological status of the site is classified as very good.

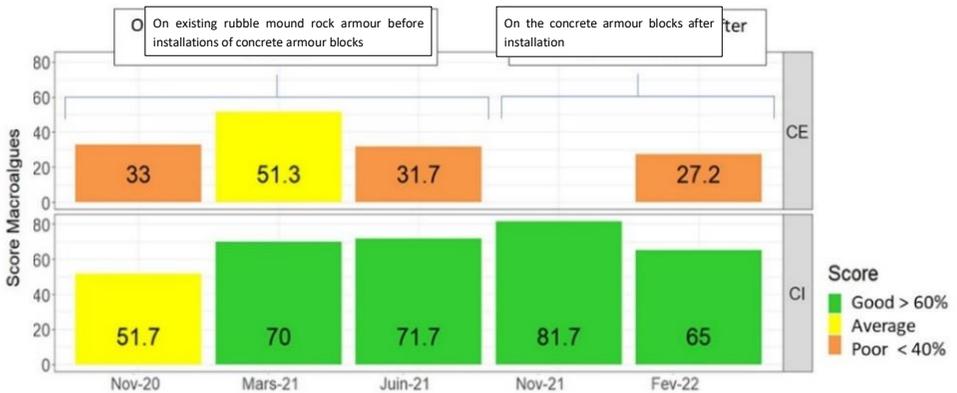
Figure 14 Scores for the evaluation of the qualitative state of macroalgae present on the rock armour around the study sites. (CE = Cherbourg External Site, CI = Cherbourg Internal Site)

Figure 14 shows the scores in the evaluation of the qualitative state of macroalgae. It is possible to observe seasonal variations on the Cherbourg sites. On the new experimental blocks, the first macroalgae were observed from November 2021, but with insufficient diversity to establish a qualitative state at this stage. Also, a significant increase in microphytobenthic biomass over time was observed at Cherbourg.

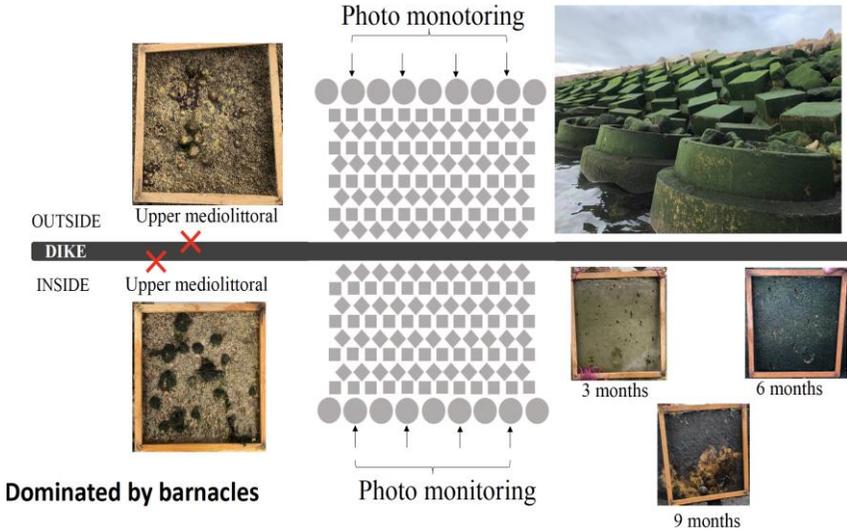
Figure 15 Monitoring of the hard-bottom benthic communities around and on the experimental breakwater

Algae species (*Fucus spiralis*, *F. serratus* and *F. vesiculosus*) dominate the upper parts of the site. The lower part of the site outside Cherbourg harbour is devoid of algae. The lower part of the site inside the large Cherbourg breakwater is dominated by a colony of gigartinales; *Chondrus crispus* and *Mastocarpus stellatus* with respectively 2% for both in October, then 20% and 3% in March. The qualitative state from a macroalgal standpoint of outside and inside the large Cherbourg harbour are respectively Average (51/100) and Good (70/100). Figure 15 shows the monitoring design on the hard bottom benthic communities surrounding and on the experimental breakwater with a low colonisation by some animals such as the barnacles and the gastropods.

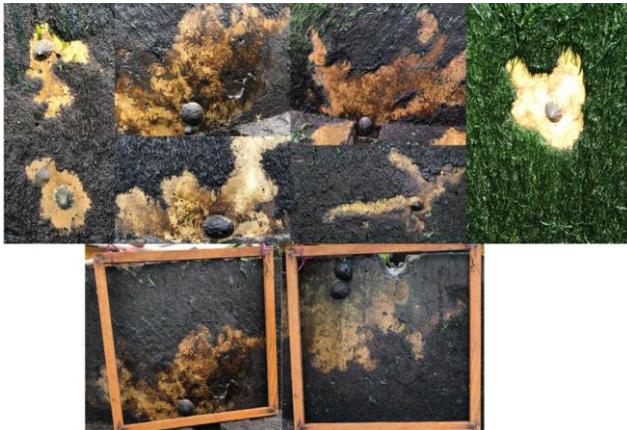
Figure 16 Picture of the gastropod *Patella* spp. scraping the microphytobenthos and macroalgae on the ACCROBERM™ II blocks in June 2022.

The *Patella* spp. found rich microphytobenthic and macrophyte biomass (micro and macro algae) on the ACCROBERM™ II concrete blocks at the end of the first year of survey showing the establishment of a trophic network between primary producers and grazers. The presence of *Patella* spp is crucial as they have a key role in growing biodiversity as they are rich nourishment of biggest predator, i.e. crustacean species.
